ITEM/2004

MI EO(2004/07/050) BENONI CCC: INJURY ON DUTY: 11 000 VOLT INCIDENT: ARTISAN ASSISTANT: MR. P MAKHETHA: INVESTIGATION REPORT

(MI/E/13/4/12)

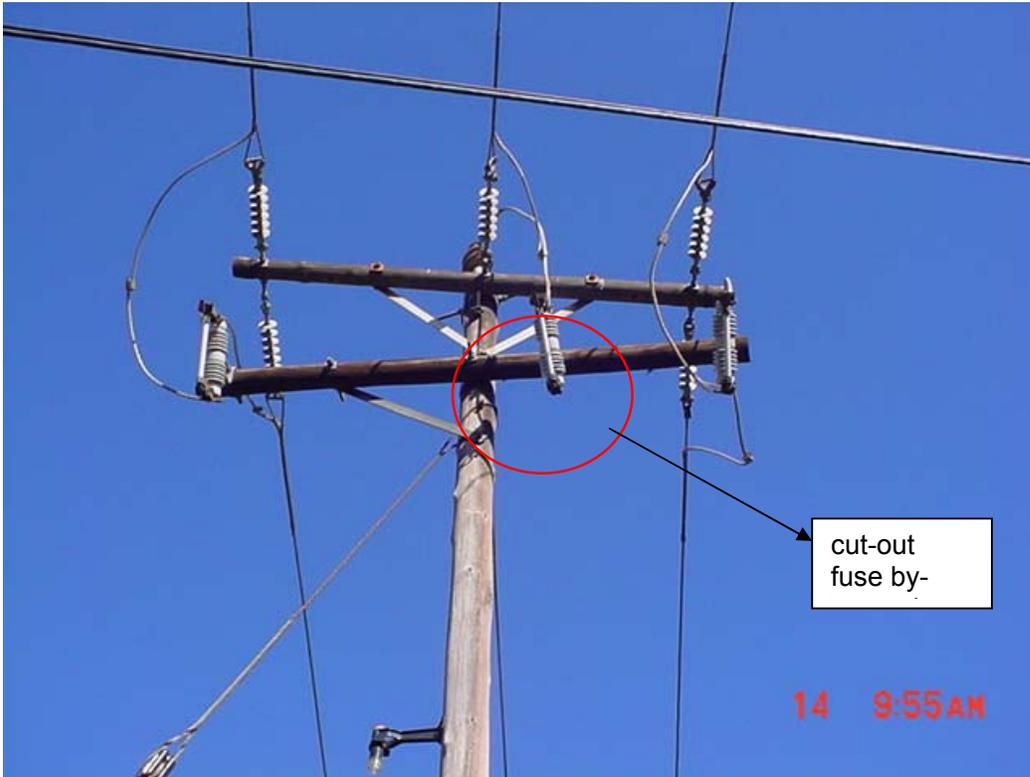
Pole BB 19/B69/1 North road, Putfontein, Benoni.

- Mr. Swanepoel discovered that, after close inspection of the overhead line circuit that the yellow or centre phase “cut-out” fuse link at pole no. BB19/B69/1 was bridged out on the line side of the fuse link. The opening of the “cut-out” fuse link, therefore, had no affect on the action taken to isolate the 11 000 volt power line.

- On Monday 14 June 2004, the Area Manager, Mr B Lamprecht and senior officials Messrs. C Day, N Barnard and J Swanepoel conducted a site inspection.
- Specific attention was given to the arrangement of the "cut-out" fuse link at pole no. BB19/B69/1 and it was concluded that two possibilities existed, namely that during the upgrading and strengthening of the rural network during the 2000/2001 Capex Budget, the "cut-out" fuse link could have been wired incorrectly or, since the said upgrade, the fuse link could have been bridged out as a "temporary repair" in order to restore power as soon as possible and the same was never normalised.

The Investigating Team acknowledges that an abnormal situation existed on the overhead line circuit in that the yellow or centre phase “cut-out” fuse link at pole no. BB19/B69/1 was bridged out on the line (live) side of the fuse link. The opening of the “cut-out” fuse link, therefore, had no affect on the action taken to isolate the 11 000 volt power line.

If this extremely dangerous and abnormal situation of “bridge out” did not occur prior to the incident, the opening of the fuse links by the electrician, Mr N Motau, would have probably isolated the line sufficient to prevent injury to personnel.

"Cut- out" links were opened in order to repair a burned-off jumper conductor at Pole BB 19/B69-4 in North road, Putfontein Benoni.

- The Acting Operations Officer Mr. J Bronkhorst, was to take the necessary corrective measures to have the subject fuse link at pole no. BB19/B69/1 correctly installed on 20 June 2004. On the said date it was established beyond any doubt that the fuse link was bridged out as a "temporary repair" by a staff member unknown at this stage, in order to restore power as soon as possible to the subject area and the same was never normalised
