REPORT: HEAD: SYSTEMS OPERATIONS

FATALITY – L.B. LOUW (ELECTRICAL ENGINEERING SERVICES)

MI EO(.....) FATAL ELECTRICAL ACCIDENT: 11 000 VOLT CABLES: BRAKPAN CCC (LANGAVILLE): SPECIAL WORKMAN: MR. W J PRETORIUS

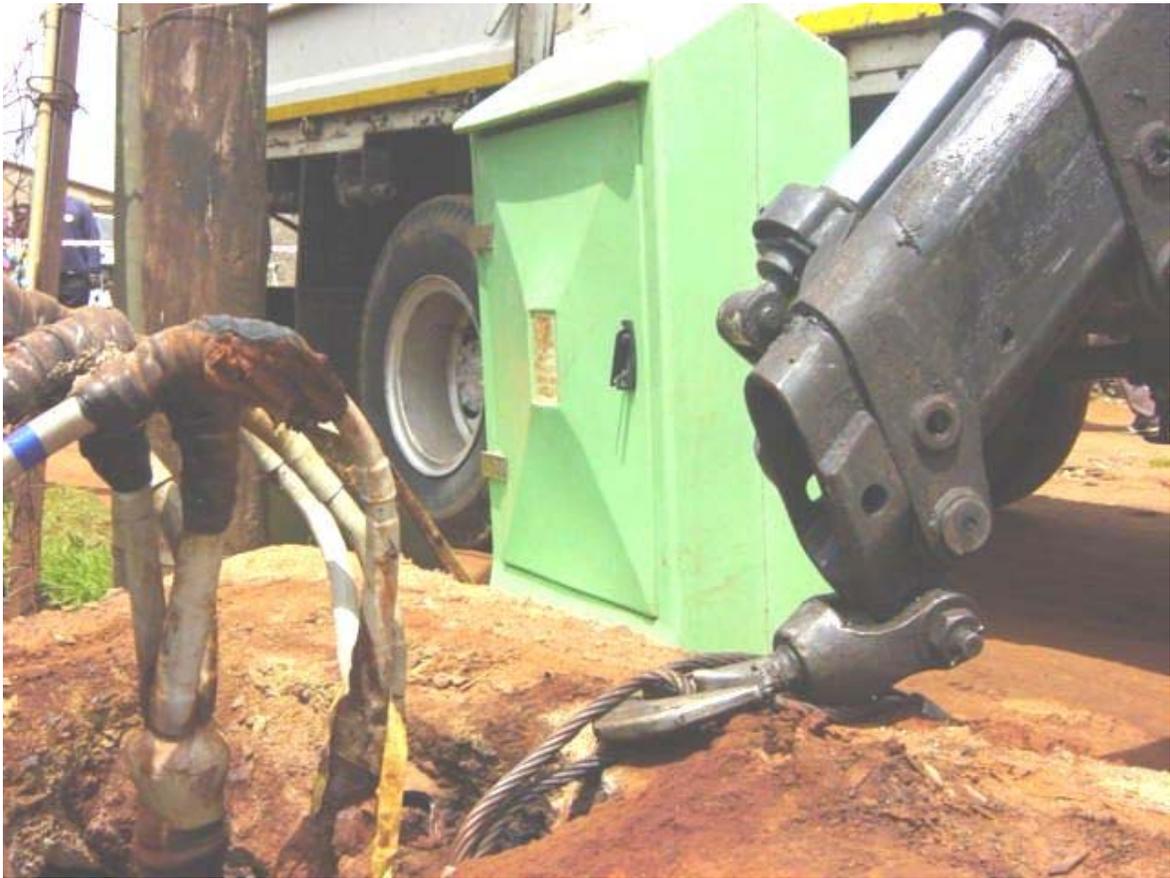
ANNEXURE "A" Photo 1

- Mr WJ Pretorius removed the steel kiosk covering the taped insulated connected 11000 volt cables. Apparently as reported, the kiosk was not locked and therefore Mr Pretorius have had access to the 11000 volt cables without keys or being accompanied by an authorised person.

- Mr WJ Pretorius apparently allowed workers to attach a steel sling around the concrete plinth whilst knowing that the 11 000 volt cables were still live (dangerous conditions prevailed). His co-worker Mr. Aaron Dihlike Mphalampela mentioned to the investigation team that Mr W J Pretorius warned him to take great care in removing an earthed connection as the cables were still live.

- Mr W J Pretorius allowed the workers to attach a steel sling around the concrete plinth to be removed with the hydraulic crane. Standing next to Council vehicle, registration number DGN 683 GP Mr Pretorius started to lift the concrete plinth

with the crane over the live 11000 volt cables by operating the required levers fitted onto the vehicle.

The risk taken by Mr Pretorius to do work close to or near live 11 000 volt cables went horribly wrong when the concrete plinth damaged the cable insulation, exposed the live conductor and consequently through the steel cable sling made the vehicle and crane live and brought Mr

Pretorius in-direct contact with a live 11 000 volt conductor ($11\ 000/\sqrt{3}$ volt) relative to earth. Under such hazardous live conditions dangerous high leakage current will flow through the body of a person.

1. **Annexure A:** Photo 1, indicating the arrangement at the site of the accident.

A written instruction is to be issued to all non-competent operating staff confirming that no person other than a person authorised thereto by the user shall enter, or be required or permitted by the user to enter, premises housing switchgear or transformers unless all live conductors are insulated against inadvertent contact or are screened off: Provided that the person so authorised may be accompanied by any other person acting under his control.

A written instruction is to be issued to all competent operating staff confirming that they are not allowed to authorize non-competent persons or unauthorised persons to unlock or enter, premises housing switchgear or transformers unless all live conductors are insulated against inadvertent contact or are screened off.
