REPORT ON ELECTRICAL INCIDENT WHERE PRIVATE CONTRACTORS WERE INJURED WHILST PERFORMING WORK ON 6 600 VOLT CABLES IN THE GERMISTON AREA: “NEAR MISS” OR A “NEAR FATAL INCIDENT”

Author & Presenter: Stephen Delpont (Electrical Engineer’s Certificate of Competency (Factories)- Chief Engineer Operations: Corporate Office: Electricity and Energy Department: City of Ekurhuleni.

Stephen Delport for the AMEU Convention 2008

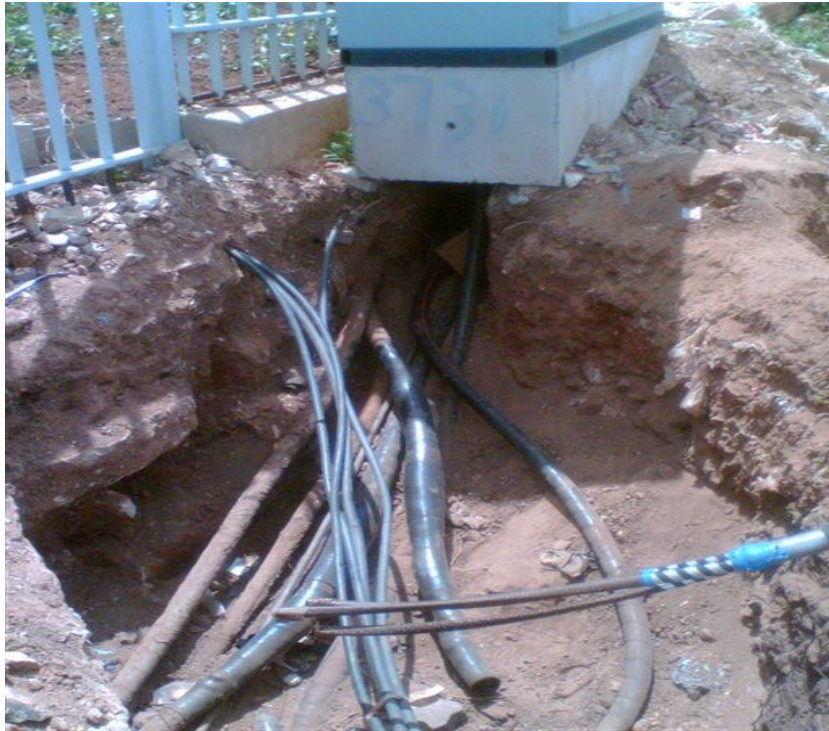
Photo 1

1. Photo 1, below showing the cable arrangements at the site of the incident corner of Newton and Essex Road.

On investigating the incident, it was found that certain on site cable work were already performed on the day prior to the incident at the corner of Newton and Essex Roads that contributed to the incident on the day of the incident.

However, the investigation team is of the opinion that should the involved operational staff had performed a basic continuity test on the day prior to the incident; they would have realized that they had identified the incorrect cable to be worked on. Thus after spiking and cutting an incorrect live cable or possibly an old redundant cable. A basic continuity test to confirm the correct cable is identified must have had been performed.

2. **That** authorized electrical operational staff **BE INSTRUCTED** to as far as practicable possible, also perform a continuity test from the point of work to proof that the correct cable/switchgear/overhead line/transformer or machinery is correctly identified. That all precautions be taken by earthing and testing to prevent applicable electrical equipment/switchgear/transformers/machinery/ wires and/or cables, or adjacent electrical machinery from being charged or made live while persons are working thereon.
