A FATALITY INVOLVING A SUB CONTRACTOR ON A SUBSTATION CONSTRUCTION PROJECT

Author and Presenter: Dwayne Baker – City Electrical Engineer of uMhlathuze Municipality.

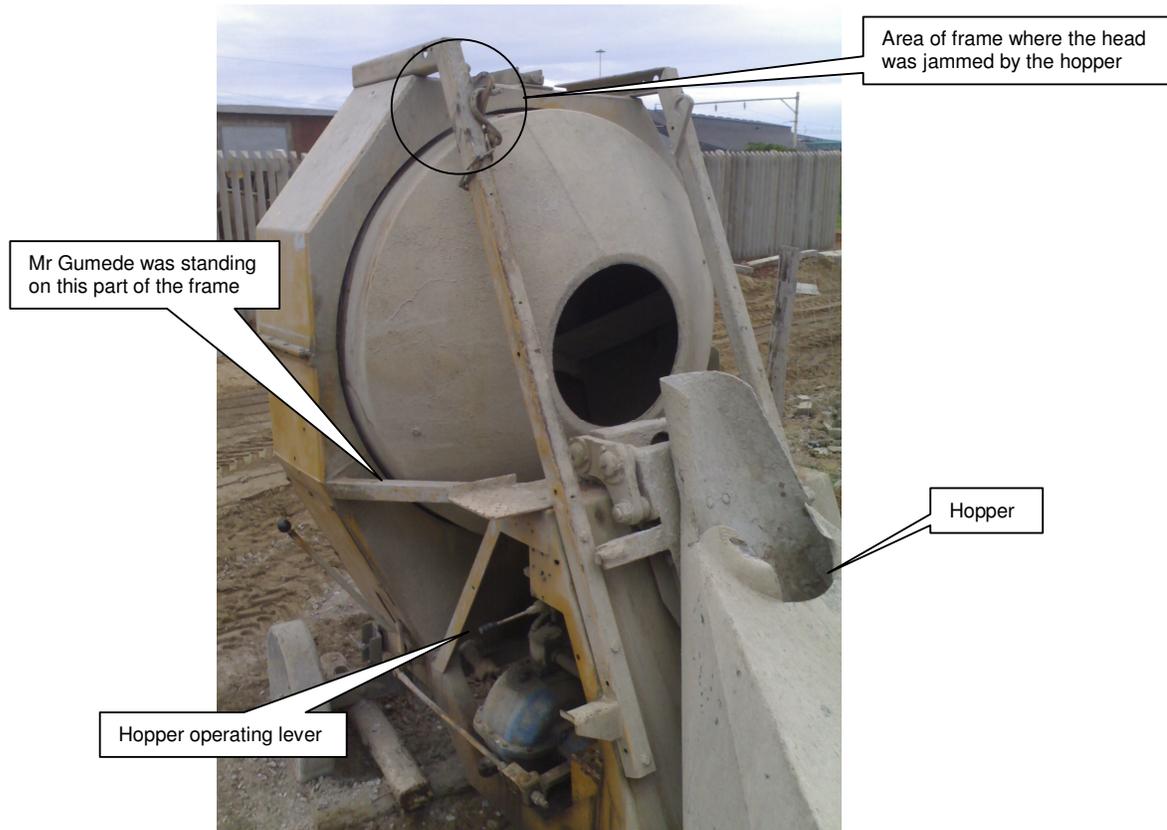
It is assumed that while standing on the frame, his foot accidentally pressed down on the operating lever, which controls the movement of the hopper.

Not realising what he had done, the hopper lifted with far too much acceleration and jammed his head against the frame of the concrete mixer, which resulted in an immediate head injury.

The following photograph attempts to illustrate the scene of the accident:

Probably the most important find is that of the unguarded hopper-operating lever. Sub clause 18 (3) of the construction regulations is clear on the safe use of any batch plant. The regulation reads that all devices used to start or stop the batch plant are constructed in such a manner to prevent accidental starting.

It can be noted that the contractor has now installed a steel guard plate to prevent such an incident from occurring again and thus fully complying with the construction regulations.
