HIGH VOLTAGE TRAINING

SUBSTATION ACCIDENT: A CASE STUDY

Author and Presenter: Barry Gass – Training Manager

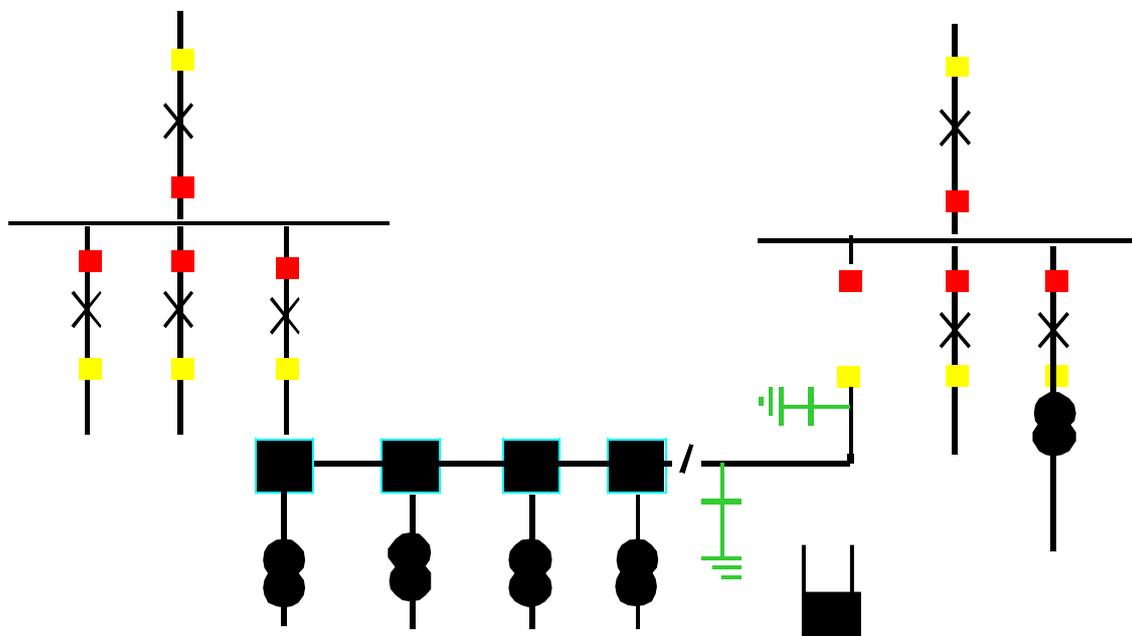
An Authorised Person had to isolate an 11kV cable, in order to cut in a new mini substation (MSS), between a substation (S/S) and a MSS. He had already Switched, Isolated, Tested and Earthed the cable on both sides correctly.
