# Innovative Test Techniques and Diagnostic Measurements to Improve the Performance and Reliability of Power System Transformers

Dr. Michael Krüger, Alexander Kraetge, OMICRON electronics GmbH, Austria  
Alexander Dierks, Alectrix (Pty) Ltd, South Africa

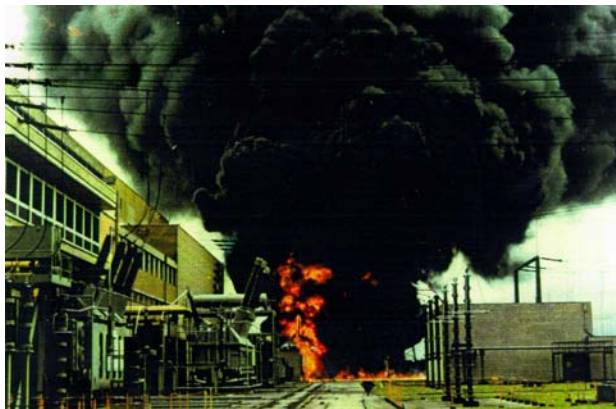
Fig. 1: Transformer fault due to a defective bushing

With the advancing age of transformers, a regular check of the operating conditions becomes more and more important. The Dissolved Gas Analysis (DGA) is a proven and meaningful method such that if increased proportions of hydrocarbon gases are found in the oil, the fault must be located as soon as possible. Hence important preventative maintenance can be performed in time to avoid an unexpected total failure (Fig. 1) [1].

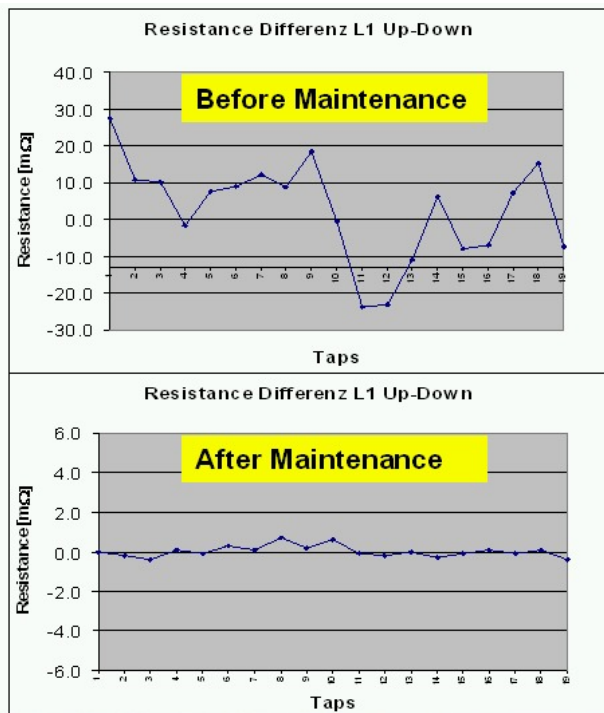
Fig. 5: Difference "UP" - "DOWN"

The deviations between switching upwards and switching downwards are likewise clearly significant. This indicates high contact resistances caused by the contacts of the tap selector switches. No silver-plated contacts were used and the copper contact surface was now coated by oil carbon. After a full maintenance of the tap selector, no significant difference to the values measured at the factory in 1954 could be observed (Fig. 4). To examine the results in more detail, it is recommended to view the difference between "UP" and "DOWN" values (Fig. 5). The difference before contact maintenance was up to 30 mΩ (or 5%) and after it was below 1mΩ (or 0.18%).

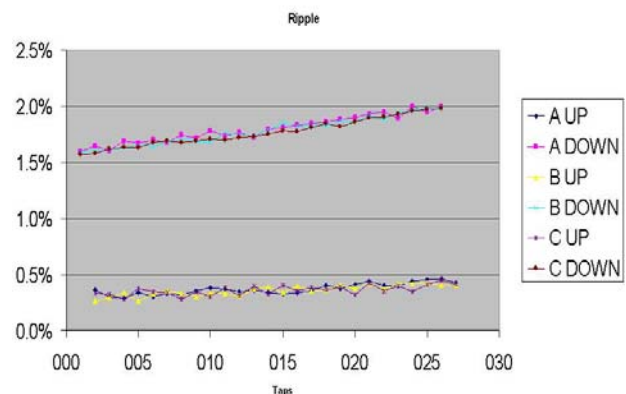
For tap changers in good condition the ripple and slope measurements for all three phases tapping UP should be similar as well as those for tapping DOWN should be similar. Fig. 7 shows a ripple measurement for a diverter switch in a good condition

Fig. 7: Ripple measurement of a good diverter switch

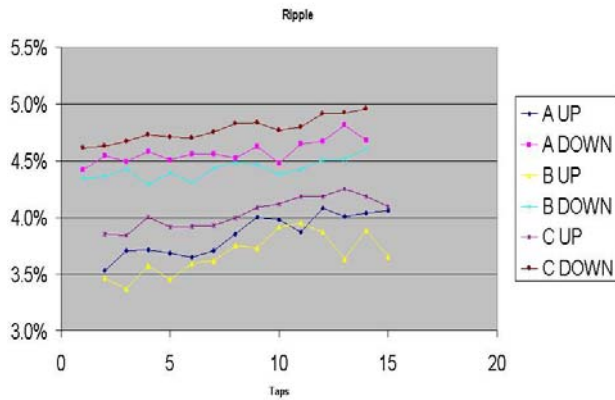
Fig. 8: Ripple measurement of an aged diverter switch

Fig. 8 shows the ripple measurements for the three phases of an aged diverter switch. The differences of the ripple values were due to the advanced aging of the diverter switch contacts (Fig. 9), which proves the sensitivity of the measurement principle to changes of the contact surface.

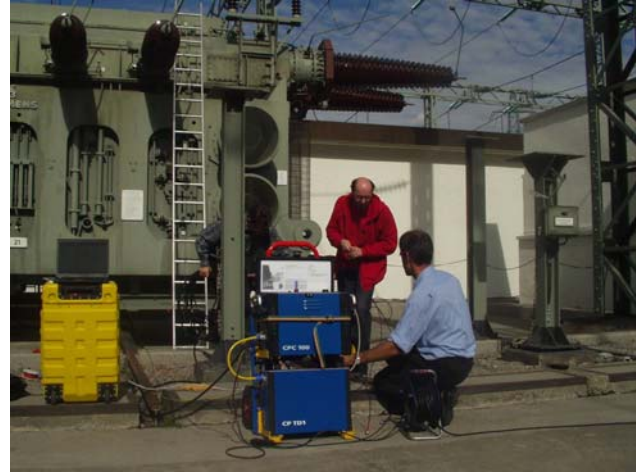
First of the ratio was measured (Fig. 10). A large difference of approximately 20% indicated a failure with 20% of the turns. The excitation current of phase A was 340 mA whereas the excitation current of the remaining phases was 10 mA.

Fig. 10: Impedance measurements on defective transformer

As a second test the leakage inductance was measured. The used test instrument has a power amplifier which allows measurements from 15 to 400 Hz (Fig. 10) [3].

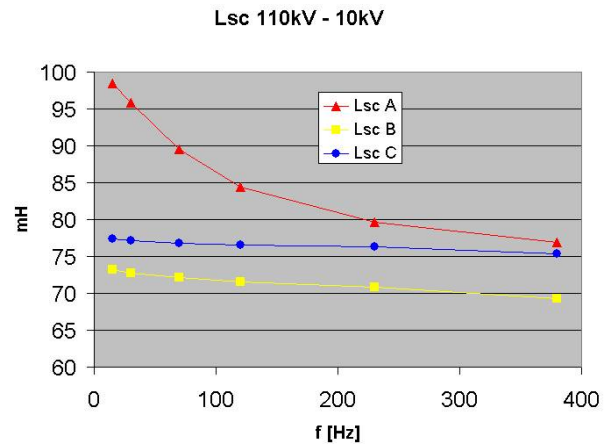
Fig. 11 shows that for low frequencies the leakage inductance of the faulty phase A is much higher than for phase B and C. For high frequencies the values are similar.

Fig. 11: Leakage inductance  $L_{sc} = f(f)$

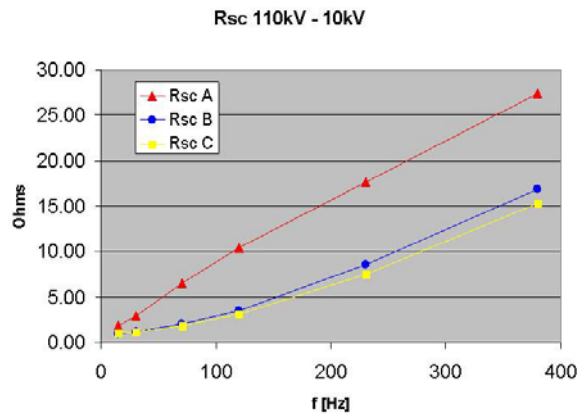
For the measurement of the Frequency Response of Stray Losses (FRSL) the resistive part of the short circuit impedance  $R_{sc}$  is measured from 15 to 400Hz. The FRSL is an indicator for short circuited parallel strands of transposed conductors. Fig. 12 shows the comparison of the three phases. The A phase shows much higher losses.

Fig. 12: FRSL measurement  $R_{sc} = f(f)$

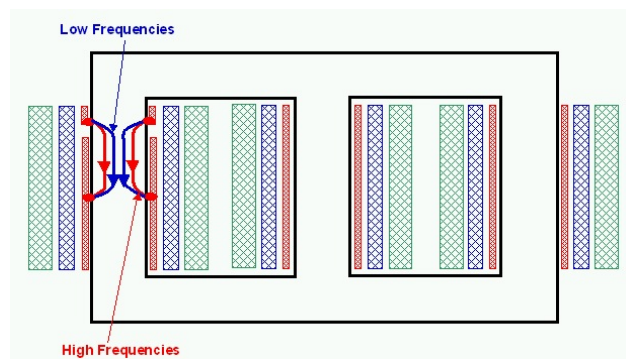
The conclusion was that the faulty winding was interrupted and parts of the winding were contacting the core. This resulted in a part of the secondary short circuit current flowing through the core. With higher frequencies the current was displaced to the core surface due to the skin effect (Fig. 14).

Fig. 14: Model of the defective winding

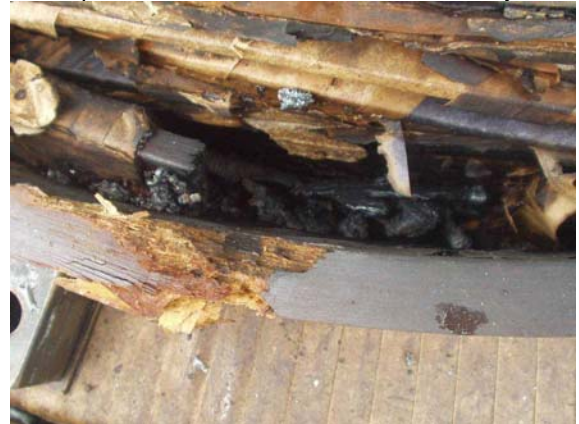
The transformer was opened three months later. Fig. 15 shows the totally damaged 10kV winding. The interruption of conductors can be seen clearly.

Fig. 15: Defective winding with interrupted conductors

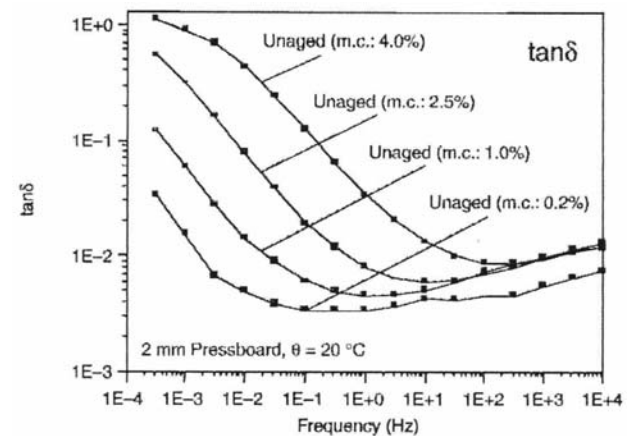
In [4] the dissipation factor (DF) of pressboard was measured at different frequencies (Fig. 16). The four curves show the  $\tan \delta$  for water contents of 0.2%, 1%, 2.5% and 4%. A transformer contains a complicated insulation system. High and low voltage windings have to be insulated to tank and core and against each other. The dissipation factor is a good indicator of the oil-paper insulation quality of the single gaps. The dissipation factor increases with degradation of oil, water content and contamination with carbon and other particles.

Fig. 16: Losses in Pressboard =  $f(f, \text{water content})$

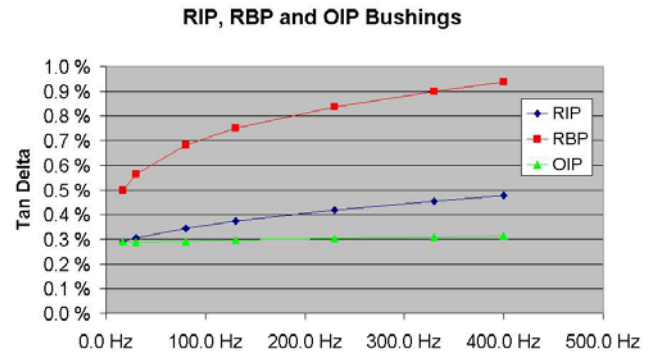
The high voltage bushings are critical components of the power transformer and particularly, capacitive high voltage bushings need care and regular tests to avoid sudden failures. These bushings have a measurement tap-point at their base and both the capacitance between this tap and the inner conductor (normally called C1) and the capacitance between the tap and ground (normally called C2) are measured. An increase of C1 indicates partial breakdowns of the internal layers. To determine bushing losses, dissipation factor tests are performed. Most of bushing failures may be attributed to moisture ingress. As already shown with the winding-to-winding insulation, analysis of bushing insulation is much more detailed when frequency scans are performed. Fig. 18 shows the dissipation factor of Resin Impregnated Paper (RIP), Resin Bonded paper (RBP) and Oil Impregnated Paper (OIP) bushings in good condition. The frequency response is rather flat over frequency and shows low values for the dissipation factor particularly at low frequencies.

Fig. 18: RIP, RBP and OIP bushings in good condition

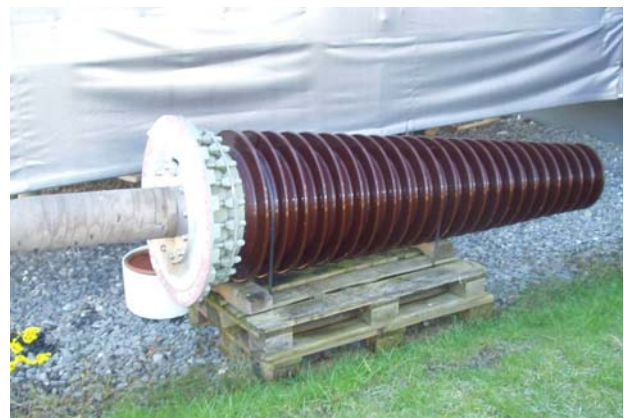
In Fig. 19 a RIP bushing is shown, which was stored outside without any protection. The first measurement was made directly after the bushing was removed from the transformer, the second measurement after three and a half months and a third measurement after more than 7 months.

Fig. 19: 245kV RIP bushing stored outside

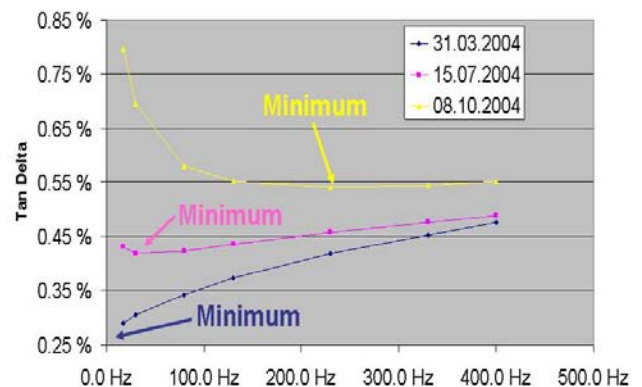
Fig. 20 shows a consistent increase of the dissipation factor as the bushing was subjected to ambient humidity and rain. Also the minimum of the curve has shifted to higher frequencies with increased humidity.

Fig. 20: Tan Delta of a 245kV RIP bushing stored outside

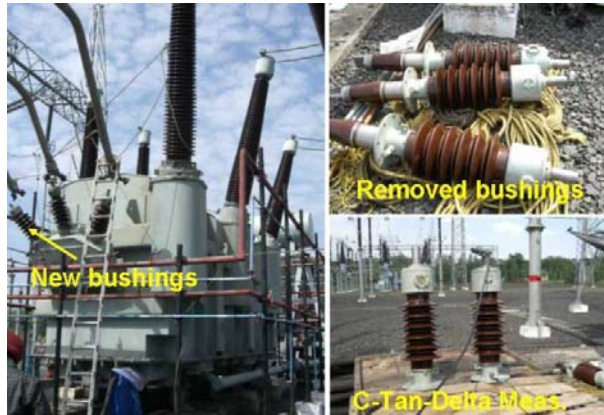
In Fig. 21 33kV-OIP-bushings are shown. The bushings were dismantled from the transformer because their dissipation factor was very high particularly at high temperatures. Fig. 22 shows the DF of dry and wet OIP bushings at 50Hz for different water contents as a function of temperature [5].

Fig. 21: 33kV OIP bushings

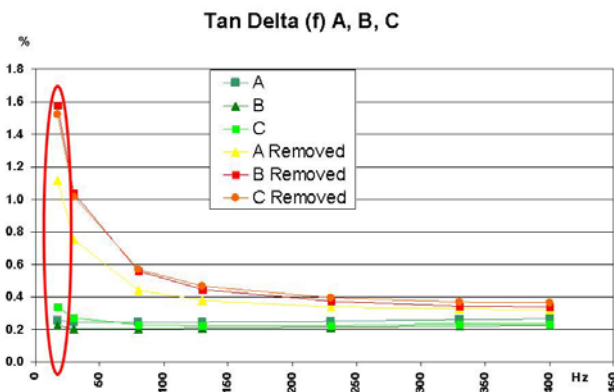
Fig. 23: TanDelta @ 30°C = f(f)

In a second test the dissipation factor for a set of replaced bushings and a set of new ones was measured at 30°C, but this time at different frequencies. The replaced bushings show high  $\tan \delta$  values particularly at low frequencies. The new bushings have flat frequency responses with low losses also at low frequencies. These tests indicated an increased sensitivity at low frequencies, which can be realized easier than the 50Hz measurement at high temperatures.
