# City of Ekurhuleni

## **Report on an electrical incident whilst performing work on a 6 600 volt cable in the Germiston area**

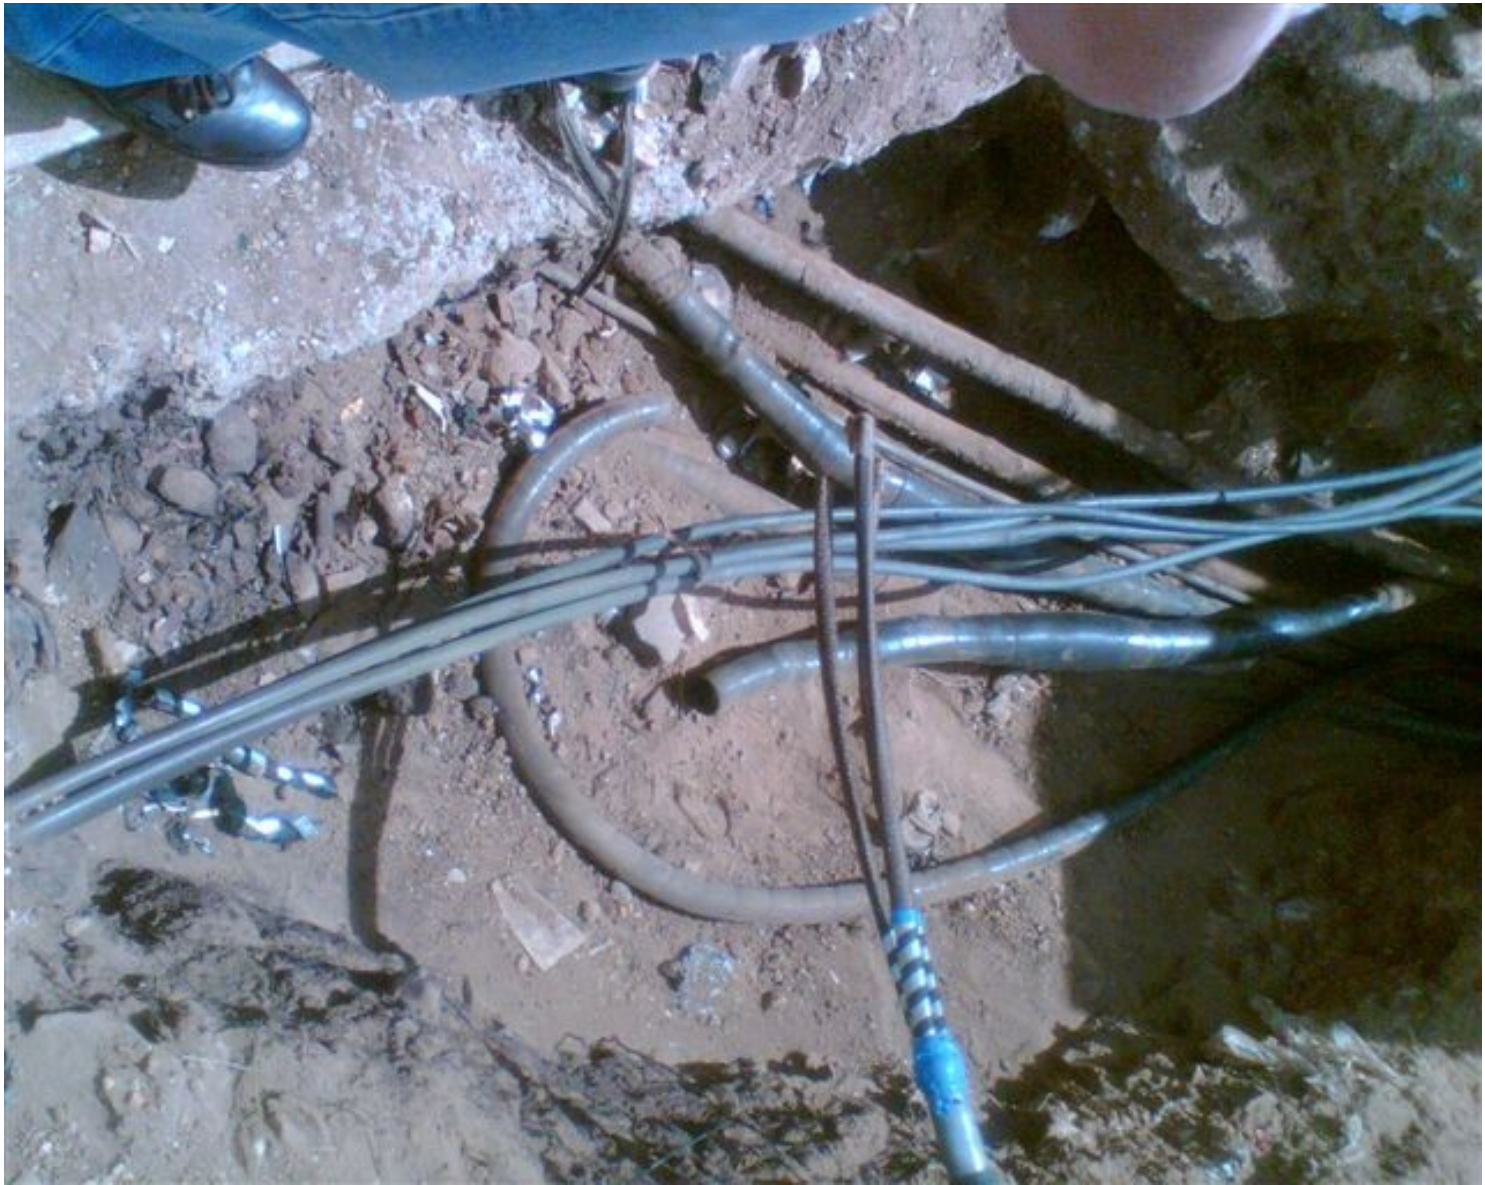
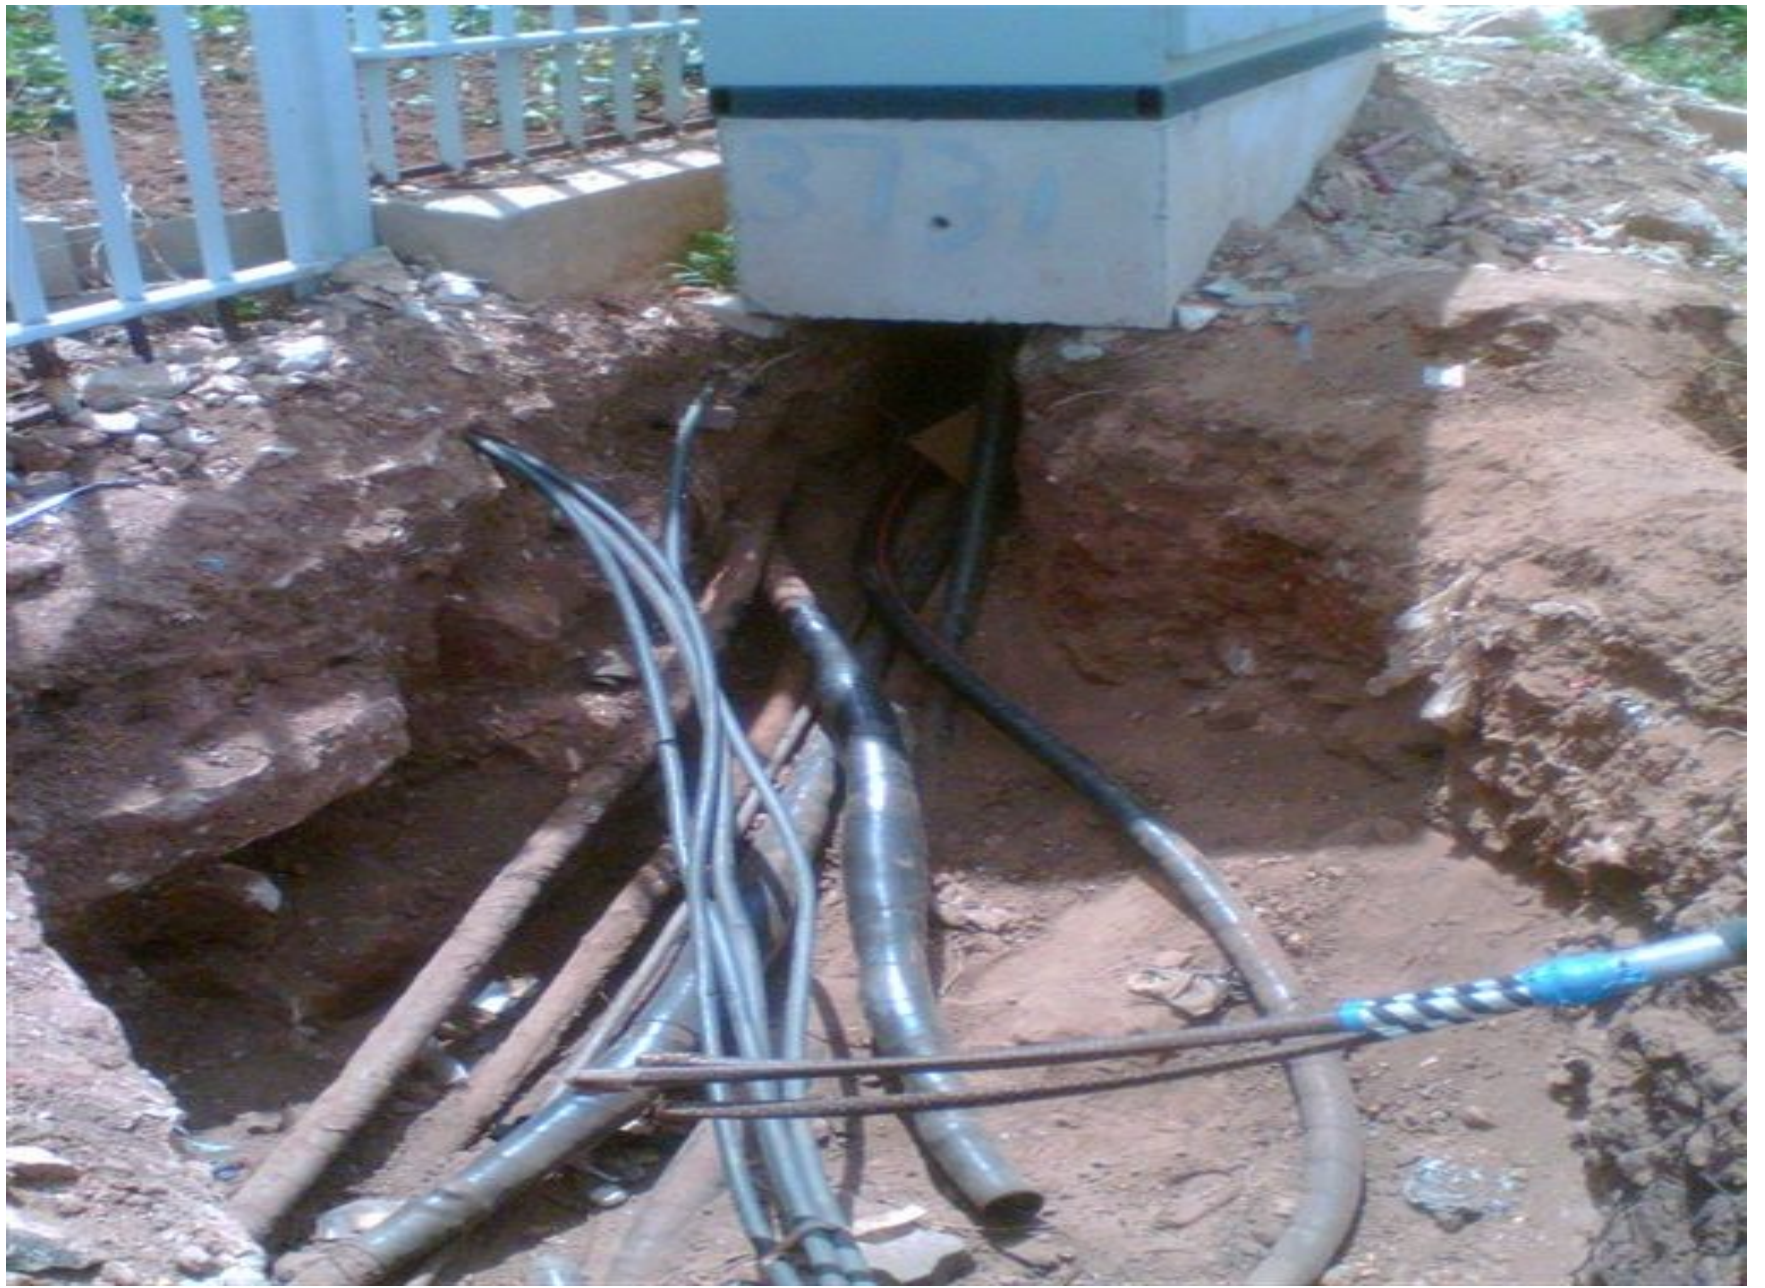
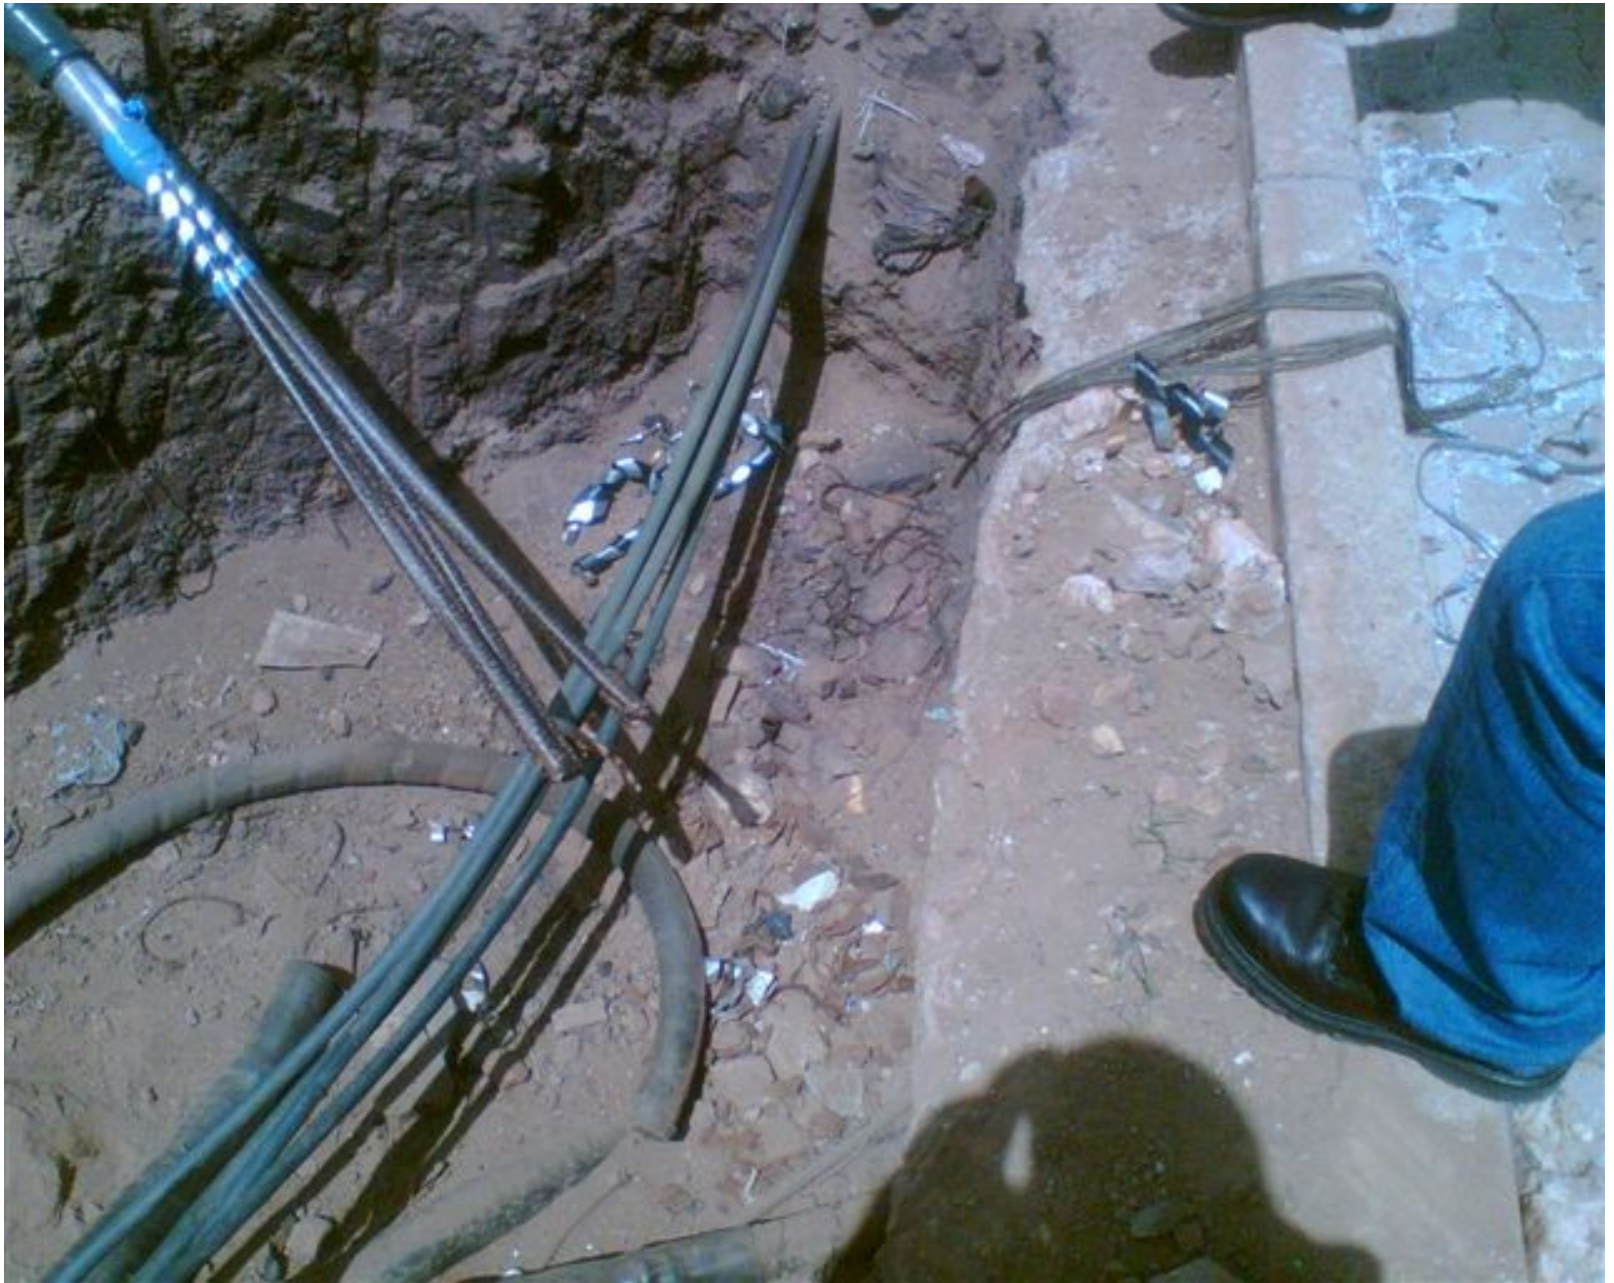
- An almost fatal incident occurred in the Germiston area, corner of Newton and Essex Roads, when three persons of a contracting firm, sustained burns whilst working close to a 6 600 volt cable when at the same time personnel of the Germiston electricity division performed switching operations.

- Apparently, once the cable was safely isolated, earthed and spiked, the personnel incorrectly assumed that they were to perform work on the “correct” required cable and that there was no hazard or danger to prevent the contractor from proceeding with the work.

- **A visible circuit element must be “switched-off”, “tested - to confirm circuit is “dead” and “earthed;”**
- **A visible “earth/s” is to be installed to protect the circuit from being electrically charged;**
- **The person spiking the cable must wear a protective safety flash suite.**
- **As far as practicable possible, a continuity test be carried out that will confirm that the correct cable/overhead line/switchgear/transformer or machinery has been earthed to prevent the danger from being charged or made live.**

- As far as practicable possible, a continuity test be carried **out that will confirm that the correct cable/overhead line/switchgear/transformer or machinery has been earthed to prevent the danger from being charged or made live.**
- As far as practicable possible no person(s) be allowed to do work in a joint pit whenever switching operations are to be performed in a specific area, even when that area is perceived not to be affected.
- Work permit to be issued, by the authorised person, to responsible personnel/contractor performing the task

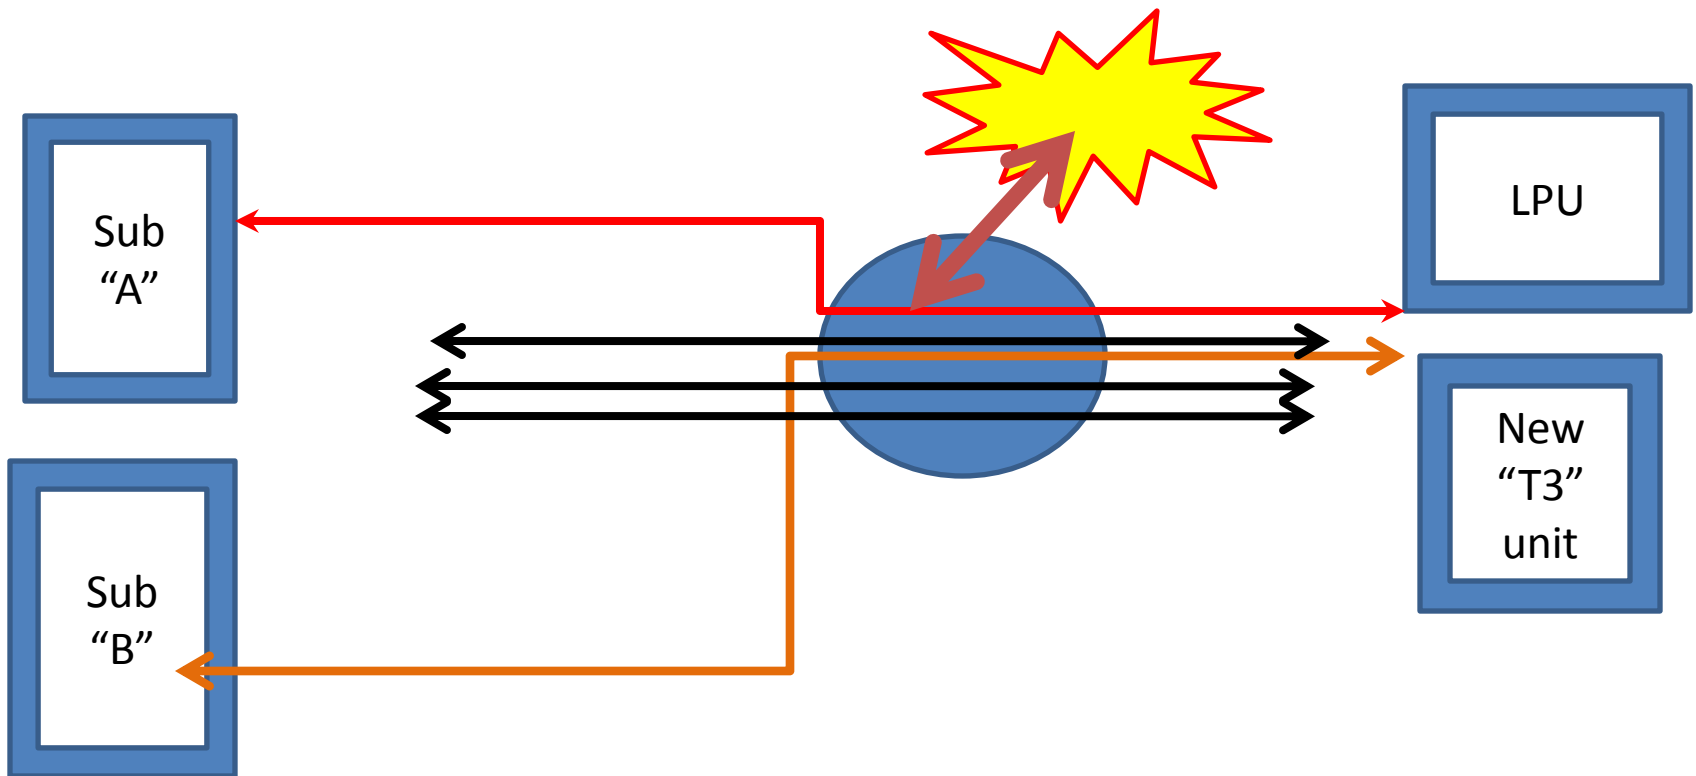
# “NEAR MISS” OR A “NEAR FATAL INCIDENT”
